Report of safety investigation

COLLISION

CMA CGM LAPEROUSE

THEBE

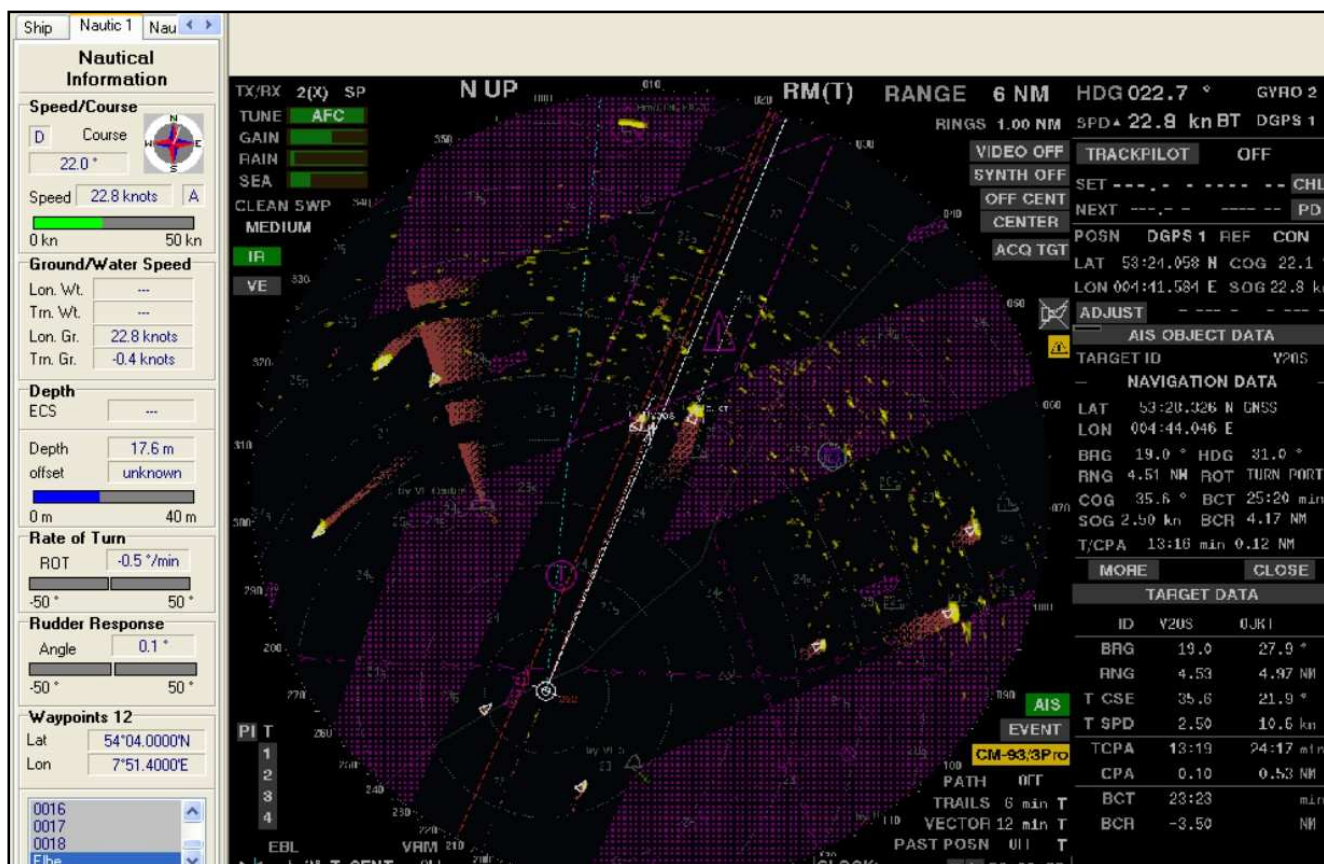
Situation at 6.08.02 pm

At **6.08 pm**, *THEBE* was at 4.5 miles in the middle of the northeast bound lane. Her CPA was 0.1 mile and her TCPA was 13 min 19 sec. Her stern light was visible to the naked eye.

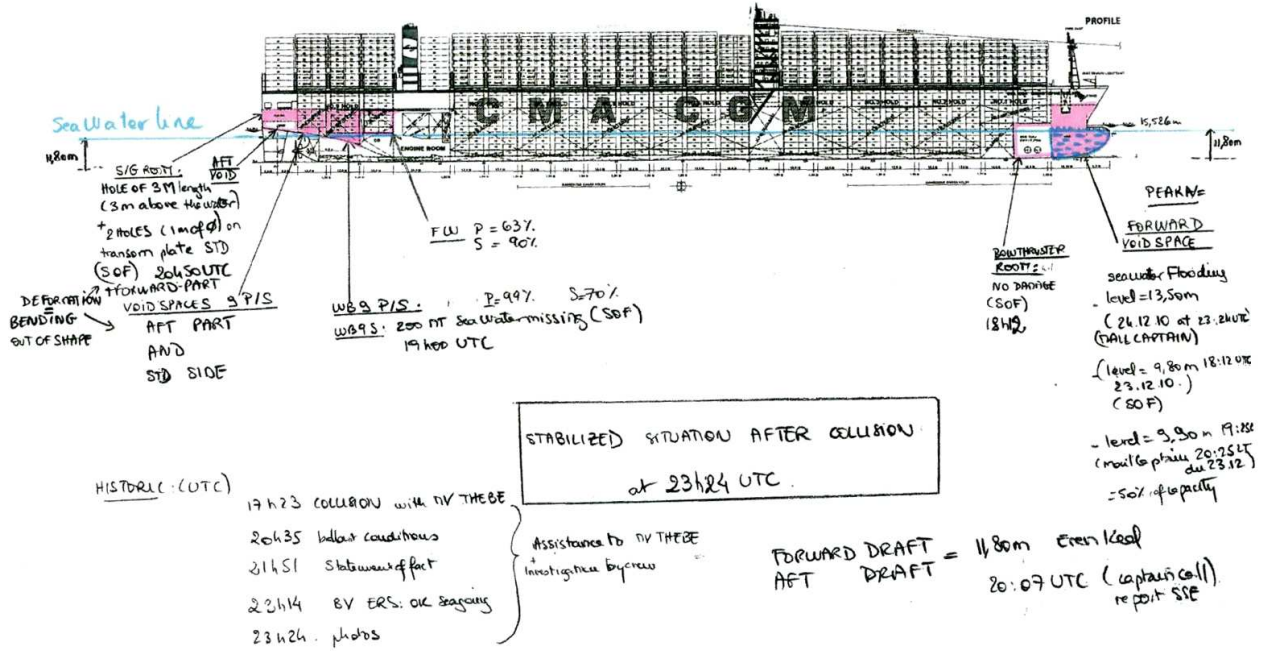
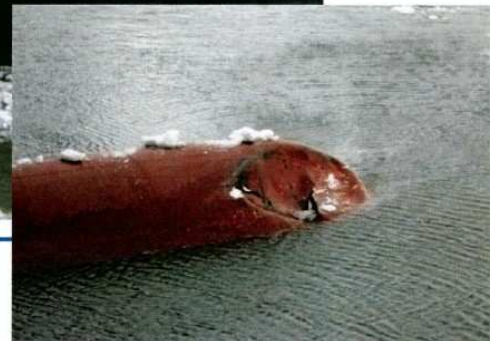
CMA CGM LAPEROUSE

During her overtaking manoeuvre, *CMA CGM LAPEROUSE* collided *THEBE* port stern with her bulb, then more on the bow with her starboard stern. There were no wounded nor pollution.

At **6.22.15 pm**, *CMA CGM LAPEROUSE* bow collided *THEBE* stern without any impact had been sensed on the bridge.

But *CMA CGM LAPEROUSE* stern collided *THEBE*. No impact had been sensed on *CMA CGM LAPEROUSE* bridge.

After her hull damages have been repaired in this port, she sailed on 12 January bound to Rotterdam.
