Report of safety investigation

STRANDING

MUSKETIER

On 8TH FEBRUARY 2011

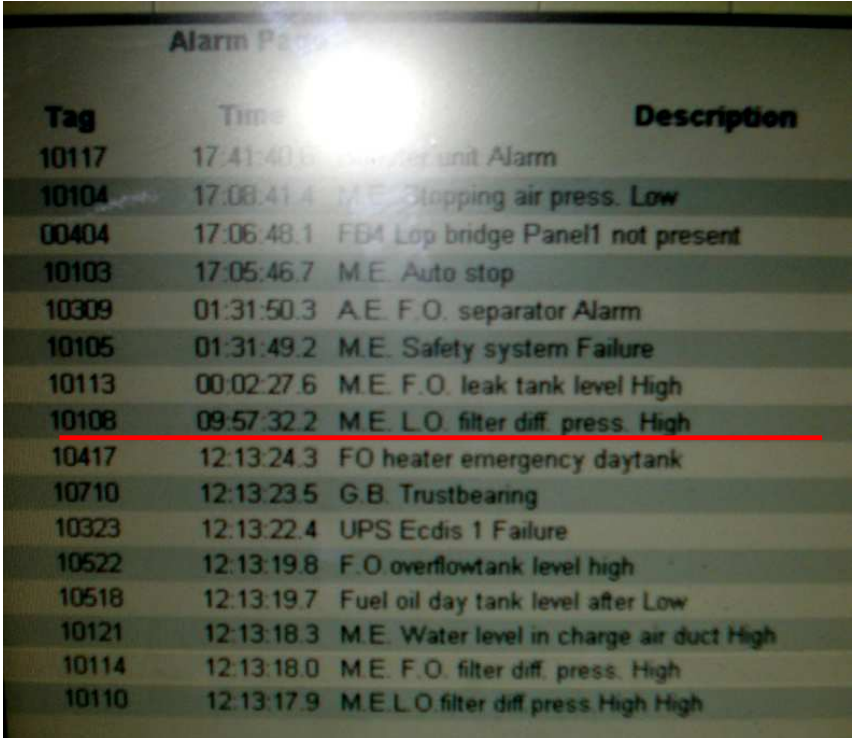
Engine alarms listing

Anyway, as shown on the picture opposite, no machinery alarm had been recorded between 10.57 am and 1.13 pm (local time). After that time the alarms recorded showed an abnormal engine temperature due to manoeuvres done by the master to make an attempt to get the vessel refloated.

No material factor had contributed to the event.

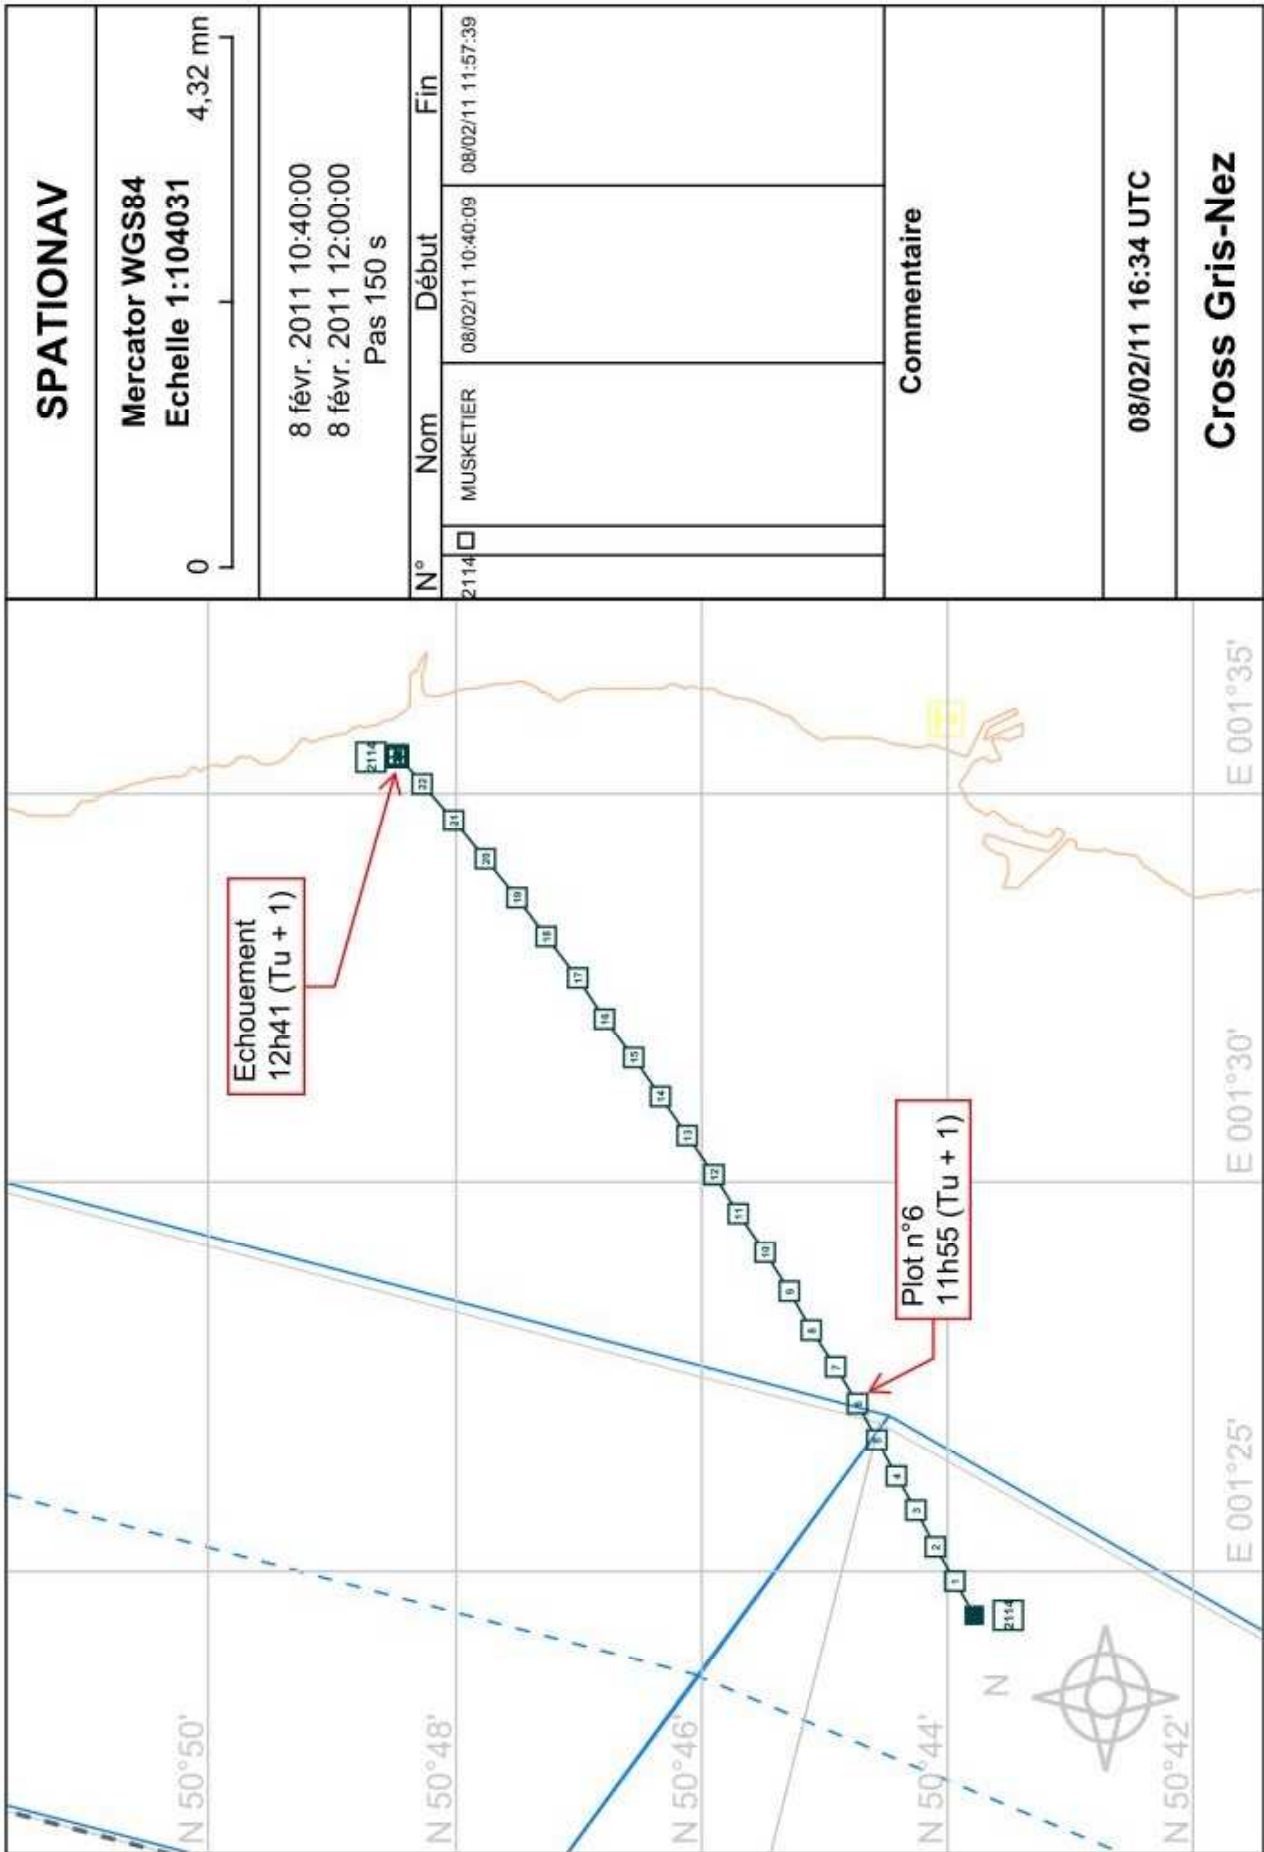
SPATIONAV trajectography

A replay of the surface situation, using SPATIONAV equipment, confirms that *MUSKETIER* crossed the edge of the northeast bound lane of the TSS at 11.56 and entered the

Inshore Traffic Zone heading 060°, speed 8 knots; that was about 45 minutes before the grounding.
